Case Study – Buckshot Damage, Most Unique Claim of 2023

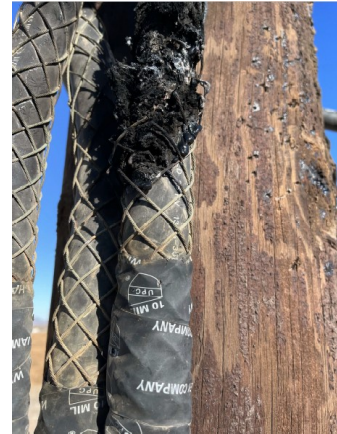
Claim: The Insured, a Public Water District, experienced the unique claim of buckshot damage to electrical supply infrastructure and distribution lines that serve a mix of buildings, groundwater pumping stations, and telemetry sites. Apparently, a bird hunter missed (several times), accidentally spraying buckshot pellets at a utility pole owned by the Insured. The ammunition ruptured several cables on the pole, including one that experienced an electrical arcing flashover, and nicked the overhead arrestor and insulator assemblies.

Challenge: The Insured conducted temporary repairs to the electrical system by stringing by-pass wiring between the load side terminations and the substation until appropriate materials could be ordered and received. However, due to supply chain issues, the procurement of replacement cabling and arrestors were being significantly delayed.

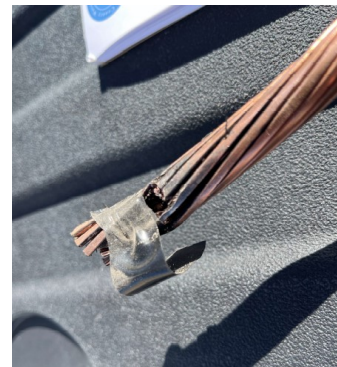
Investigation: Equipment Damage Consultants (EDC) conducted a remote damage assessment and Like Kind and Quality (“LKQ”) costing analysis of the actually damaged infrastructure system components, in comparison to current market-based costs, to verify the replacement cost value for this claim. The identification of what was damaged was of significant concern to the Property Claims Representative, as the initial photographs provided by the Insured included an electrical substation (34.5kv primary) containing several expensive and difficult to obtain (supply chain issue again) transformers. However, in working with the Insured, we were able to verify that A) the Insured, and not a separate electrical utility, did indeed maintain and operate the substation under the United States Bureau of Reclamation; but that B) no damages occurred therein.

Findings & Value: We worked with the Insured to identify in-stock sources of the materials needed, reducing the down-time and costs for additional temporary repairs. We also assisted in the necessary differentiation of temporary repair versus permanent repair cost, including the documentation and rates for the Insured’s use of in-house labor and equipment (bucket trucks). By working these issues in advance and through continuous communications with the Insured, we were able to recommend an LKQ/RCV (\$23,442.00) very similar to that which was finally claimed (\$24,042.00), to the delight of both the Property Claims Representative and the Insured for this unique event.
