Insured: [REDACTED]
Claim #: 07-21448-2.1 EDC File #: 820-07
D.O.L. = 07/01/07 or 07/02/07 (Reported)

Final Report

This letter serves as our final report on the above referenced claim involving reported lightning damage to a rooftop Heating, Ventilating and Air-Conditioning (HVAC) unit, at a restaurant located at [REDACTED], Allentown, PA.

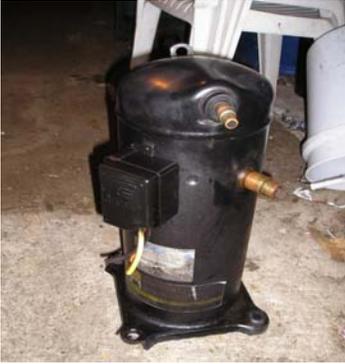
Relative to the most probable cause of the loss, it appears that the HVAC unit failed due to normal wear and tear. The Copeland compressor (model ZR57K3-PFV-250, serial number 95K488472), as shown in Figure 2, did exhibit both the described refrigerant oil leakage as well as thermal damage to the internal AC power cable connectors (see Figure 3). However, the finding of cooling coil damage (see Figure 4) points to refrigerant leakage and subsequent loss of oil lubricant as the mechanism which caused the failure event. Loss of the lubricant would cause the compressor to overheat, leak further oil, draw continuous high current and melt the internal power cable connectors as was witnessed during our inspection of the compressor. The lack of tripped breakers on the unit and on the single phase 208V circuit adds evidence to this failure mechanism.

Figure 2. Damaged compressor

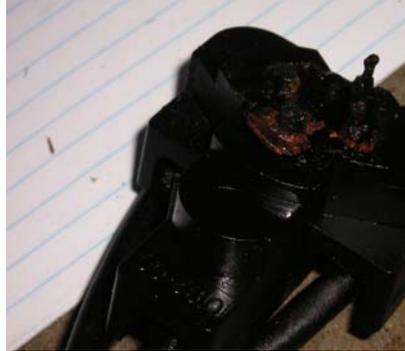
Figure 3. Compressor AC connector

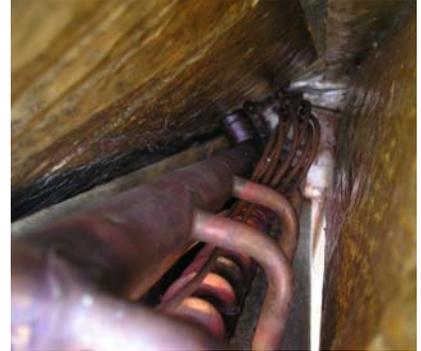
While a direct lightning strike to the unit could have led to the electrical damage seen on the compressor, it would not have caused the damage to the internal, well shielded cooling coil.

Figure 4. Damaged coil

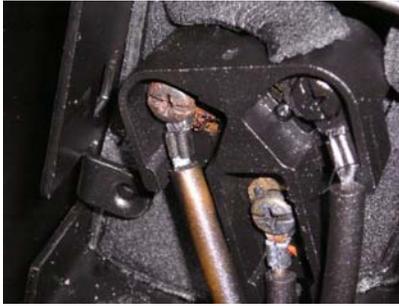
Figure 6. External compressor
connector

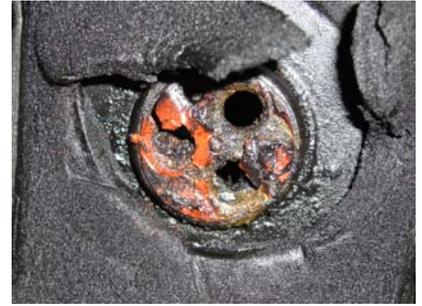
Figure 7. Internal compressor
connector
