EQUIPMENT CLAIM TIMES

A Newsletter From Equipment Damage Consultants

Impact of Muriatic Acid on Stainless Steel Appliances

Case Study

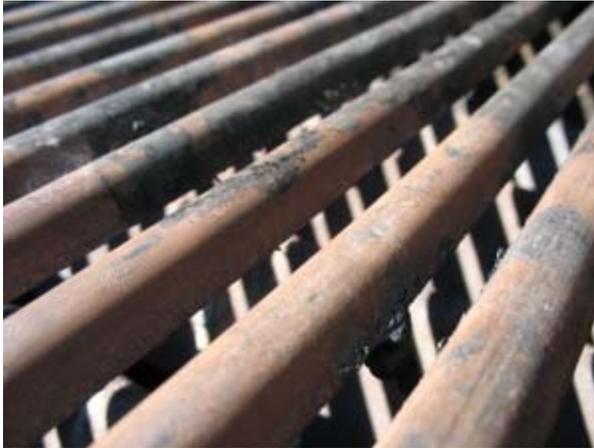
However, chloride salts (metallic salts are formed when such surfaces are in the presence of hydrogen chloride vapor) either in excessive concentration or over a large amount of time, will form pits or "pitting corrosion" on Grade 304 stainless steel. This pitting, which can only be

formed by chlorides, is very difficult to remove even with abrasion. If the chloride concentration is high enough or too much time has passed, the surface will never be able to be restored.

Photograph of a rusted 304 stainless steel grill grate.

Of interest relative to the case study is that the two cleaners used by the Insured both contained "oxalic acid". This substance functions as a de-rusting agent by preferentially forming an "oxalate" with rusted iron, displacing ("precipitating") the rust and exposing the underlying bare metal. The use of this substance, followed by abrasion, allows the re-formation of a passivated, corrosion resistance surface on the stainless steel.
