## EQUIPMENT CLAIM TIMES

Volume 3, Number 3

May 19, 2009

### Case Study - HVAC Condenser Lightning Damage?

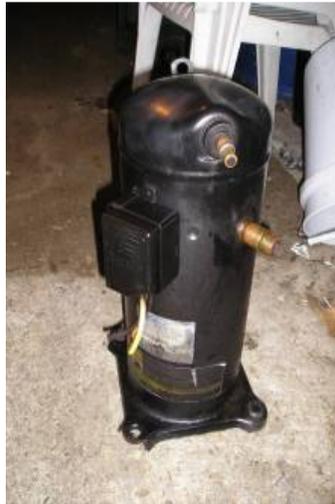
The on-site assessment revealed that compressor did indeed have burnt wiring at the electrical connector, indicating either surge damage or an overheating event. A closer examination of the burnt connector showed that the wiring was intact but the wiring insulation and connector plastics were melted. A significant amount of an oily substance was also evident around the connector and on other surfaces of the compressor. An examination of the rest of the condenser again showed an oily substance on many surfaces. The reason for the need to replace the cooling coil also became apparent when a hole in the copper piping was discovered.

The lack of evidence for lightning damage provided by lightning verification analysis and weather database examination led to the need for an on-site assessment for this claim. The proposed replacement of the cooling coil led to a suspicion that something more than electrical damage was involved in the cause of this loss. The finding of damages to the condenser cooling coil provided the answer to the cause of the event - loss of refrigerant. The refrigerant not only acts as a heat exchanger in HVAC systems, but also contains oils that serve to lubricate the compressor. The loss of refrigerant in this system caused overheating of the compressor, leading to a melt down of the electrical wiring connector (with the subsequently described smoke and electrical flash) and failure of the HVAC system. Normal wear and tear was the final determined cause for the event.
